**Public Information Statement**  
**National Weather Service Melbourne FL**  
**348 PM EDT Thu Jun 8 2023**

**...NWS Damage Survey for Jun 7, 2023 South Patrick Shores Tornado Event...**

**.South Patrick Shores EF-1 Tornado...**

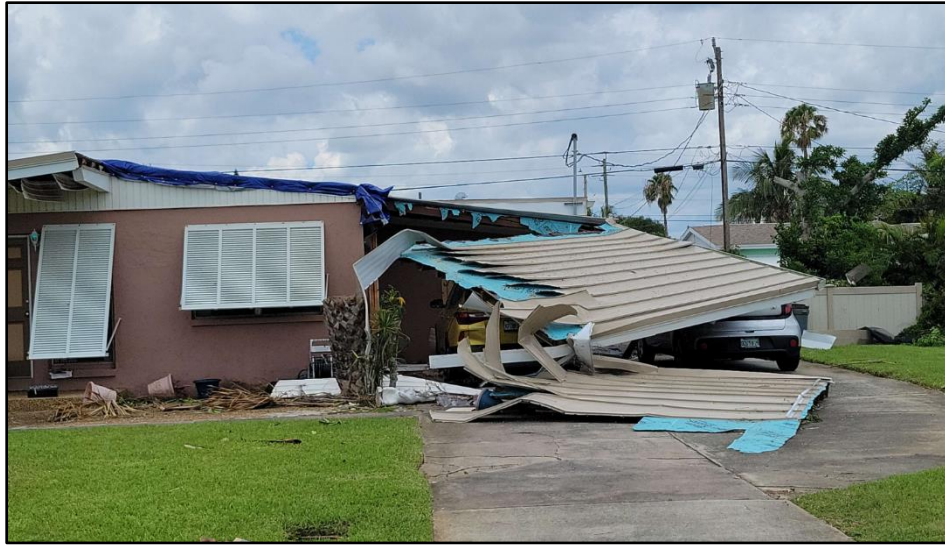
**Figure 1.** The carport of a home was tossed atop vehicles on Pelican Dr. in South Patrick Shores, FL. (Photo: NWS Melbourne)

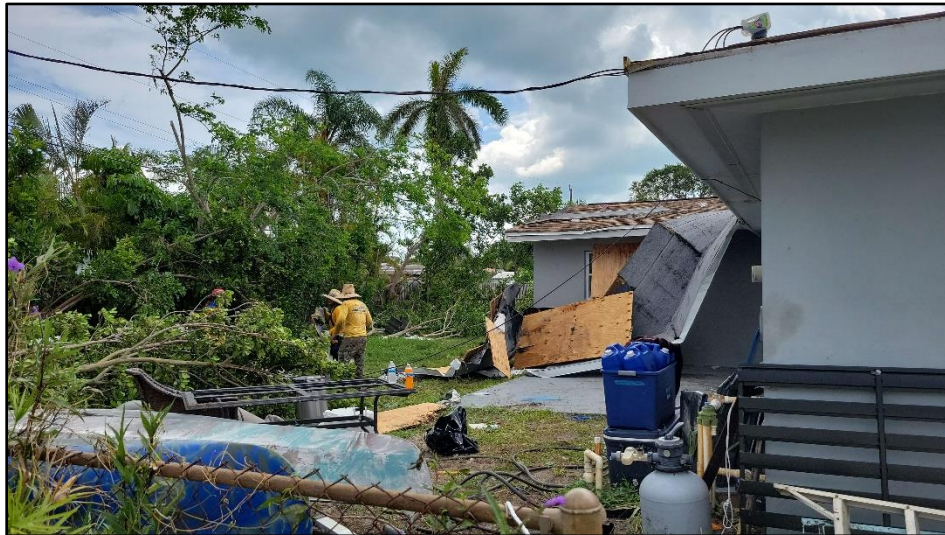
**Figure 2.** A porch awning and part of an attached roof was torn from a home near the intersection of SE 1<sup>st</sup> St. and Albatross Dr. in South Patrick Shores, FL. (Photo: NWS Melbourne)

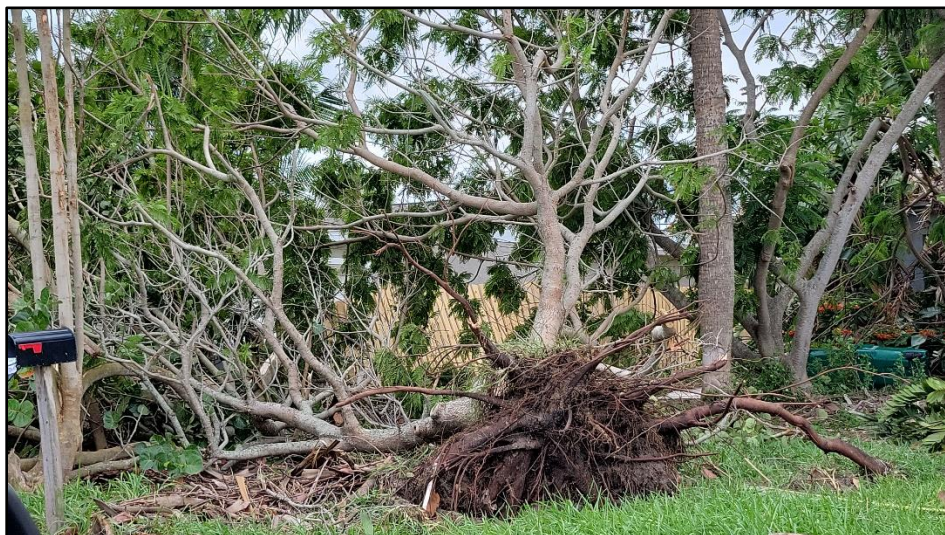
**Figure 3.** A large tree was uprooted along Egret Dr. in South Patrick Shores, FL. (Photo: NWS Melbourne)
